Offshore Cable Installation - Lillgrund

Lillgrund Pilot Project

Type of document REPORT	Document identification 3_2 LG Pilot Report	Rev. No. 1.0	Report date January 29, 2009	Project No. 21858-1
Author Oscar Unosson		Project name Lillgrund Pilot Project		
Customer Vattenfall Vindkraft AB		Reviewed by Åke Larsson		
		Approved by The Reference Group		
Distribution The Swedish Energy Agency			No. of pages 30	No. of appendices 0

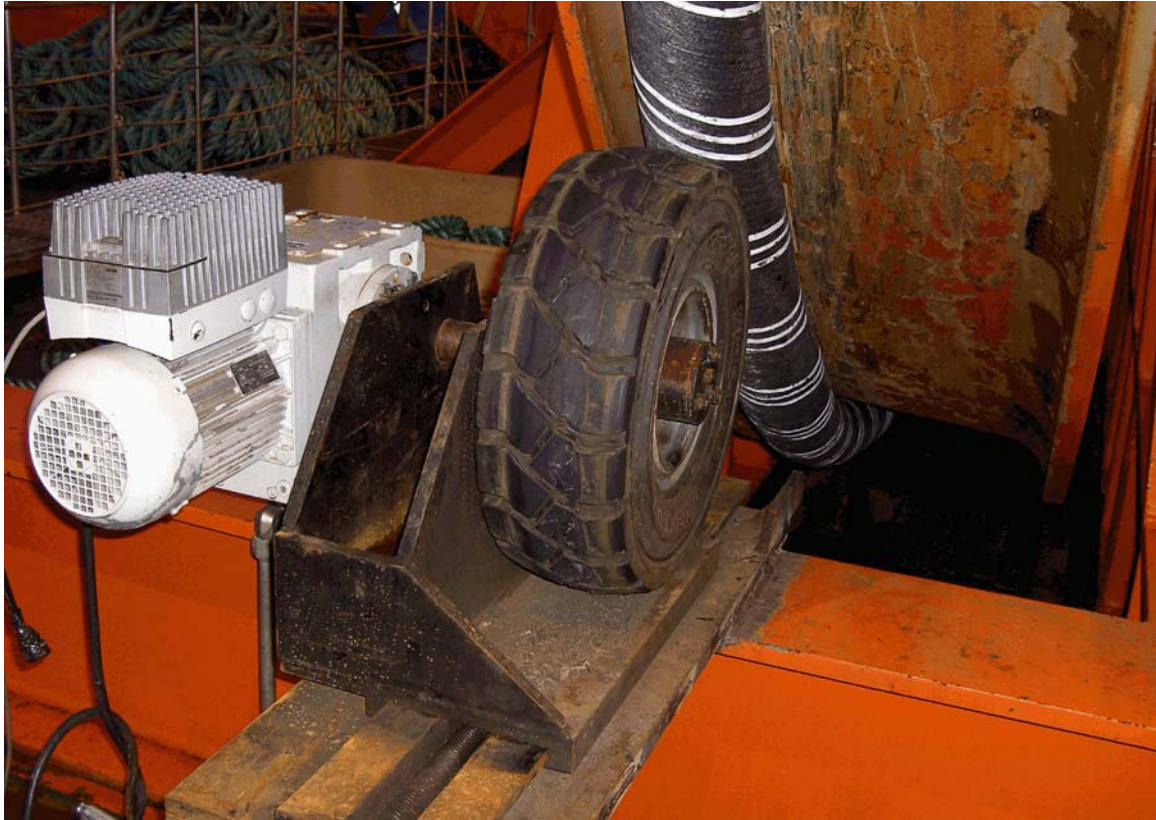
Figure 10. The motor installed with the wheel pressing onto the cable at the capstan.

After attempts using harder bindings around the vespa as well as a higher hydraulic pressure, an electric motor was installed with a wheel which pressed onto the cable at the capstan, figure 10.

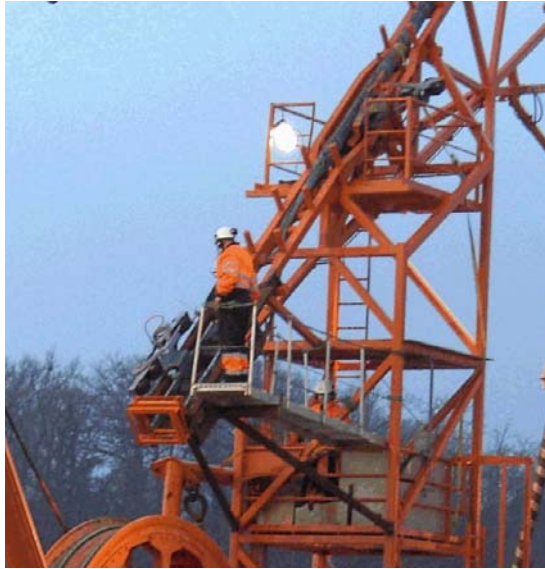
Figure 11. An extension was built on the “gooseneck” where the vespa was built-in.

Before the pre-laying exercise was carried out, a new construction was added to the “gooseneck” which included an extra vespa. The new construction was an extension of the “gooseneck” where the vespa was built-in, figure 11.

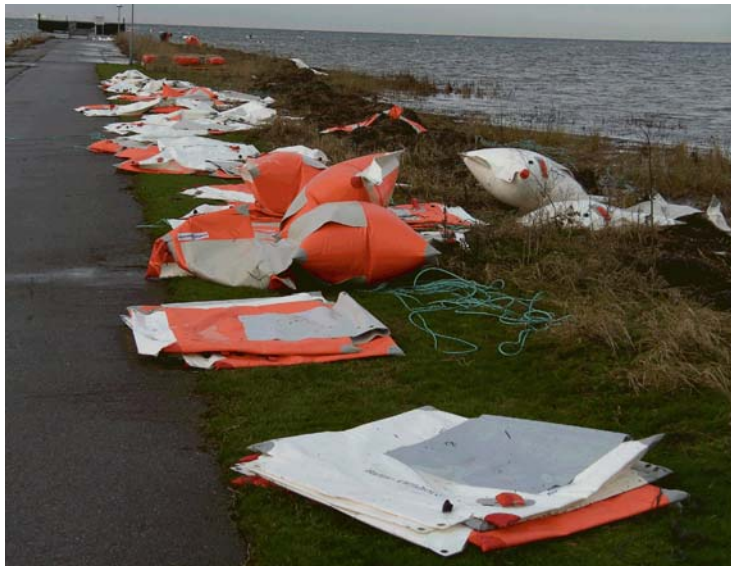
The floating bags that were used during the submerging of the cable were not disposed of immediately, which caused temporary debree scattered along the shoreline. Divers walked or swam the whole shoreline in the bay to collect floating bags, figure 15.

Figure 15. The shoreline was filled of floating bags after the submerging.

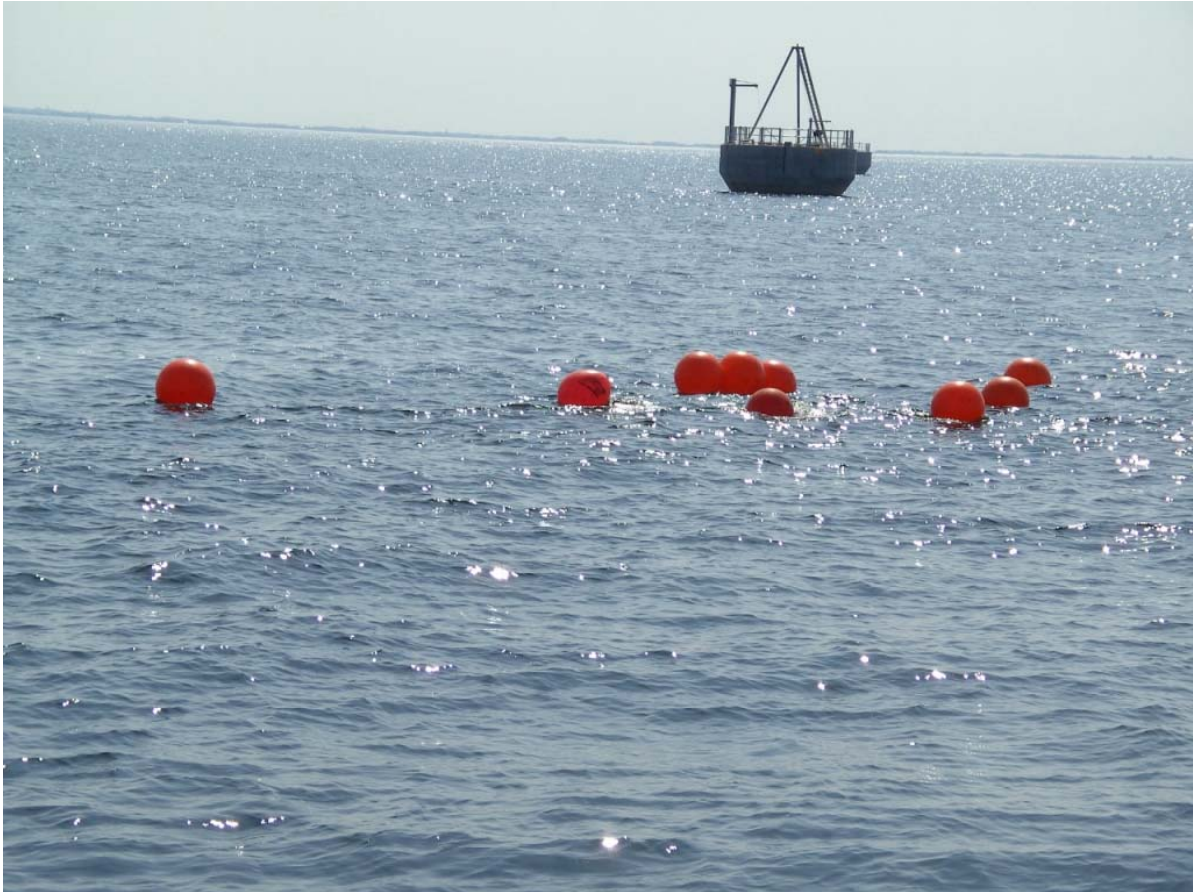
During the time the cables were positioned on the floaters, operators had to be aware that the ocean currents could have moved in a direction, which could have caused a kink in the cable during the pull-in, figure 22.

Figure 22. The water current affected position of the cable and the floaters during the pull-in.

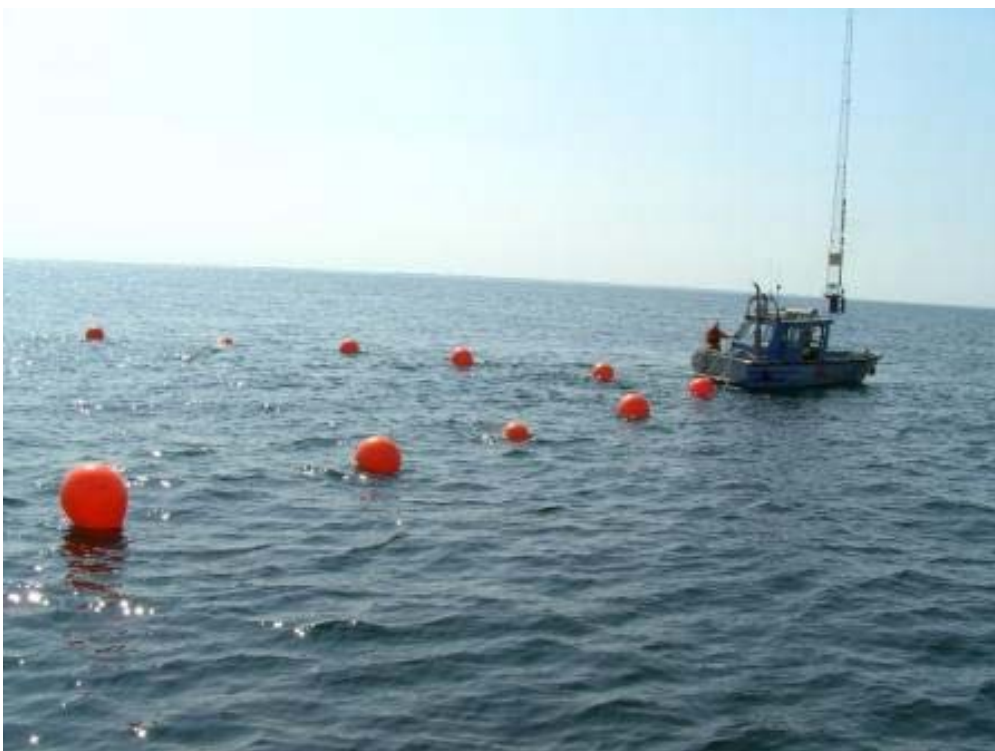
Due to water current pulling the cable there was sometimes a risk that the cable would get a kink. During those risky pull-in operations the workboat pulled the cable to minimise this risk, figure 25.

Figure 25. A workboat pulled the cable to minimise the risk for a kink
