Offshore Cable Installation - Lillgrund

Lillgrund Pilot Project

Type of document REPORT	Document identification 3_2 LG Pilot Report	Rev. No. 1.0	Report date January 29, 2009	Project No. 21858-1
Author Oscar Unosson		Project name Lillgrund Pilot Project		
Customer Vattenfall Vindkraft AB		Reviewed by Åke Larsson		
		Approved by The Reference Group		
Distribution The Swedish Energy Agency			No. of pages 30	No. of appendices 0

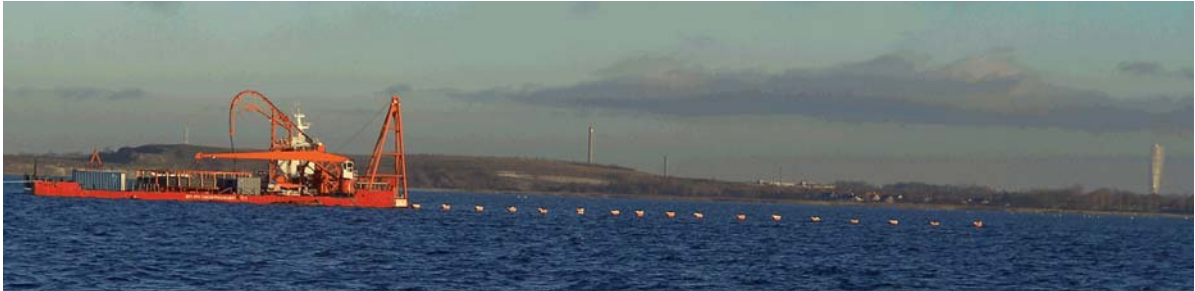
The weather conditions improved and an attempted pull-in of the cable was approved. Although the barge had moved slightly from its position due to the wind, this did not pose a

Figure 12. Inflated airbags took the cable towards shoreline.

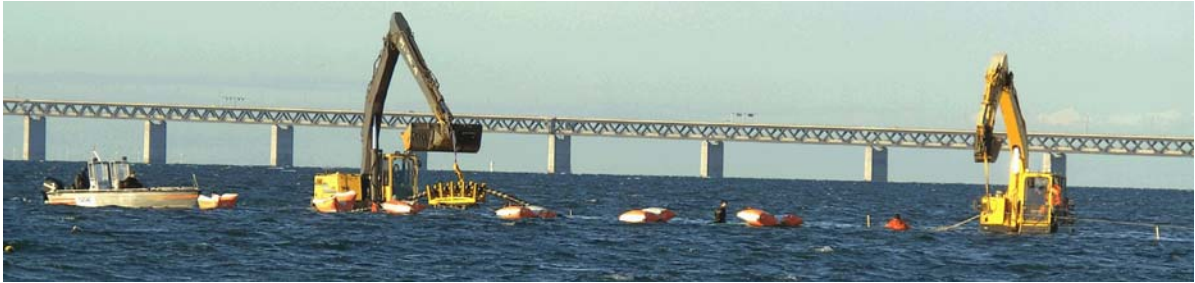
In front of the cable, a small workboat was used to keep the course towards the excavators. The tide was higher than expected, so the excavators could not reach as far as planned. Instead, a larger workboat was used to reach the steel wire with the cable. The wind came from the back but the water currents came from the starboard side. The steel wire was too heavy for the workboat. A bigger workboat managed to reach the steel wire with the end of the cable. When the Chinese finger was secured to the steel wire, the excavator and an onshore winch fulfilled the pull-in, figure 13.

Figure 13. The cable pull-in made by the excavators and a pull-in winch. A bigger workboat and two divers were also used.

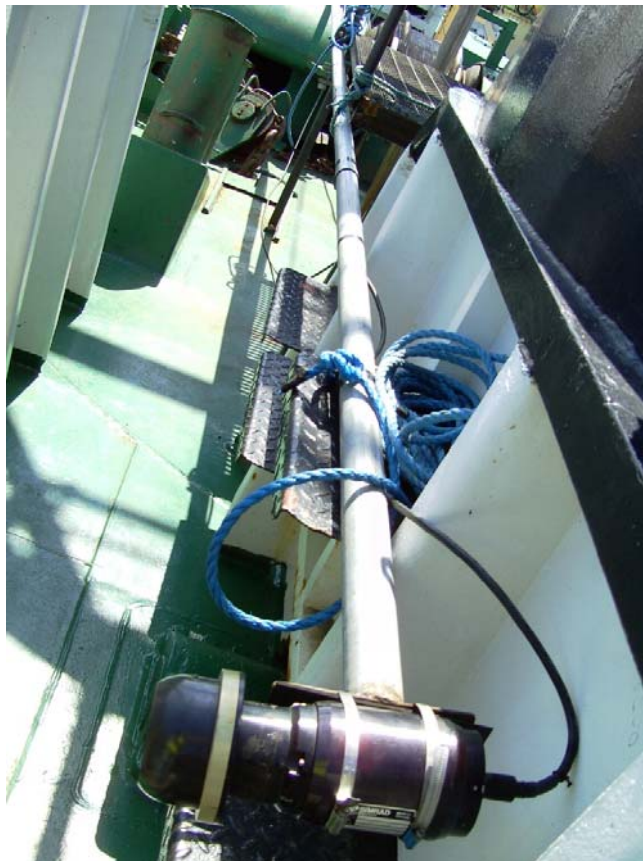
Another difficulty was that the linear cable engine did not manage to hold the cable in place. Steel plates were installed so the cable could not move laterally.

To be sure it worked, the profiler, which was installed in the bow, ran a sound of the bottom. The lead line and the results from the profiler should correlate. Figure 20 shows the profiler assembled on a steel tube.

Figure 20. The profiler seen is attached to a steel tube, and is fastened at the bow, one meter below sea level.

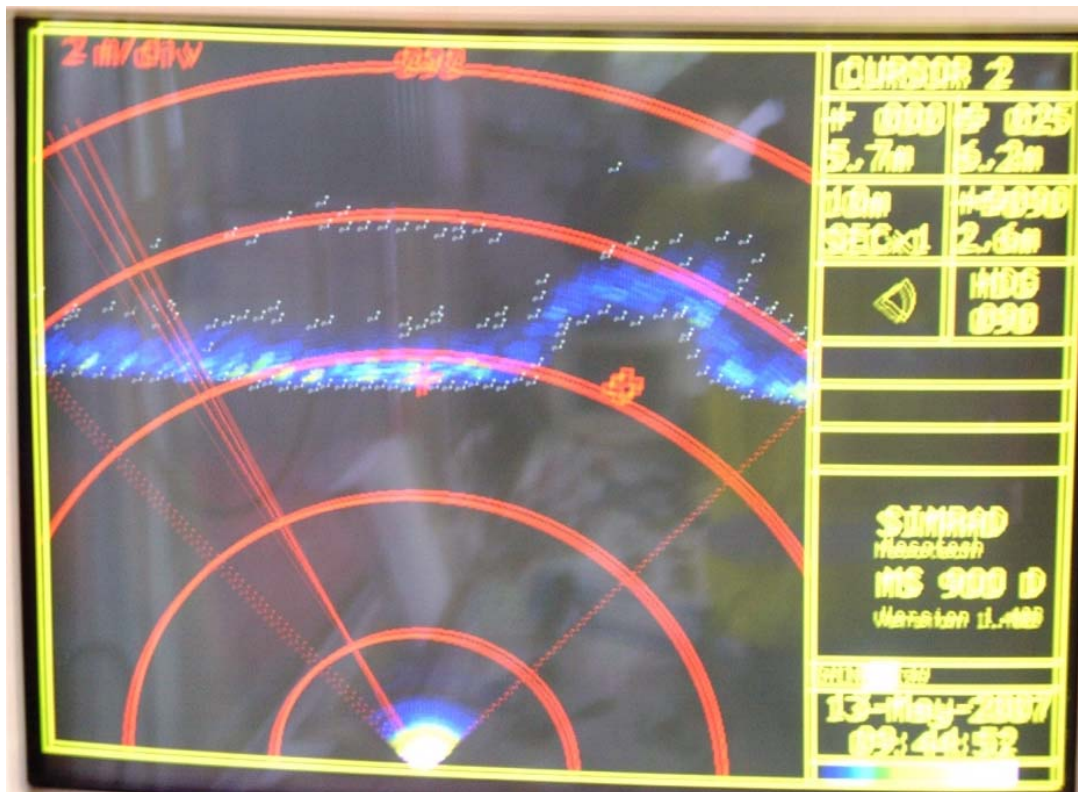
Figure 21. Plot of the profile above the trench. The blue is the surface of the seabed and the red circles every second meter from the profiler in the centre. The profiler is not directly over the trench.

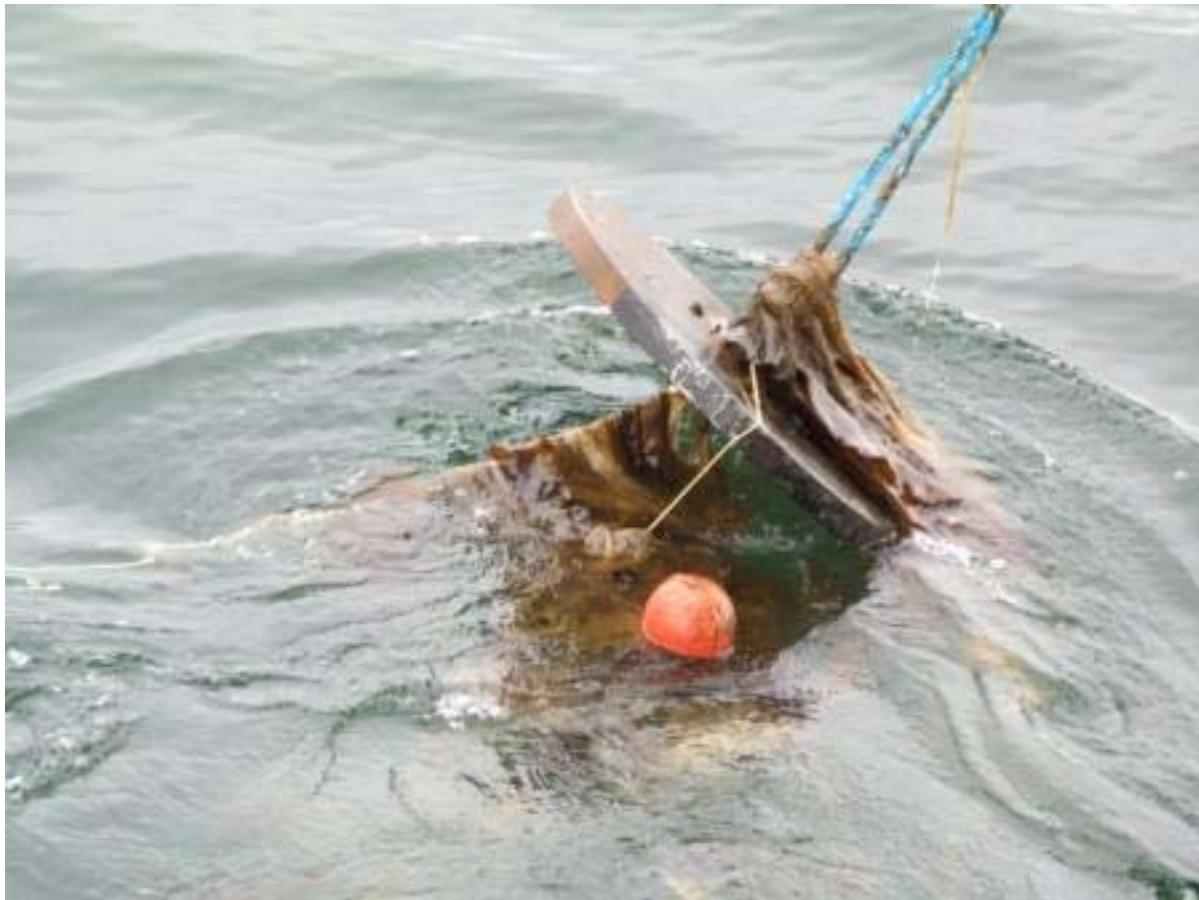
In every foundation there was a j-tube from the seabed to the top of the foundation, which was designed for the cable. One meter below the seabed, a bell-mouth with an enclosure cap, was mounted on the j-tube. The enclosure cap had to be removed before the cable pull-in, figure 23. Mud had filled in outside of the enclosure cap, requiring divers to vacuum the space before every pull-in so the cap could be removed. Because of the water current direction, clearing the space in front of the caps took 15 - 30 minutes each on the south sides of the foundations and up to two hours on the north sides of the foundations.

Figure 23. The enclosure cap removed from the bell mouth.

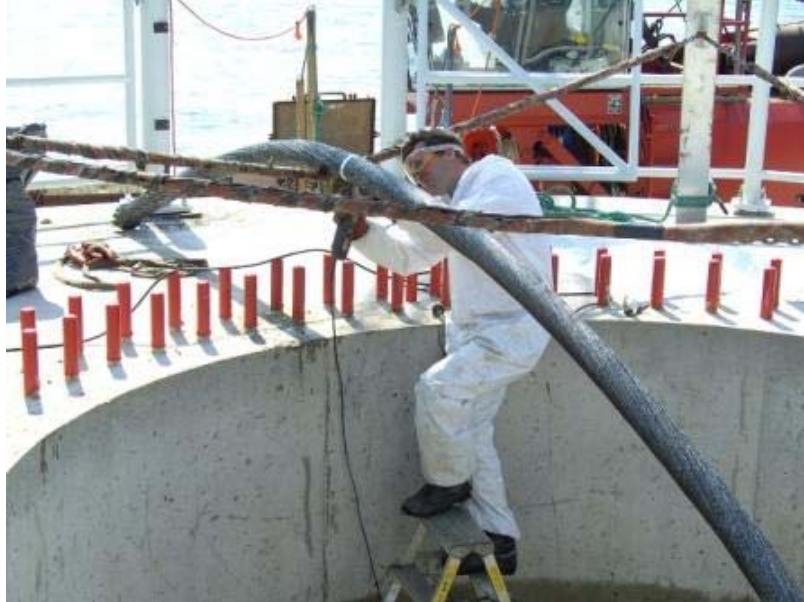
To ensure that enough cable was provided to each foundation, the cable was pulled 6 - 8 meters above the j-tube top. The cable armour was removed for this length before the cable was secured, see figure 26 below.

Figure 26. The cable armour was removed with help of an angle grinder

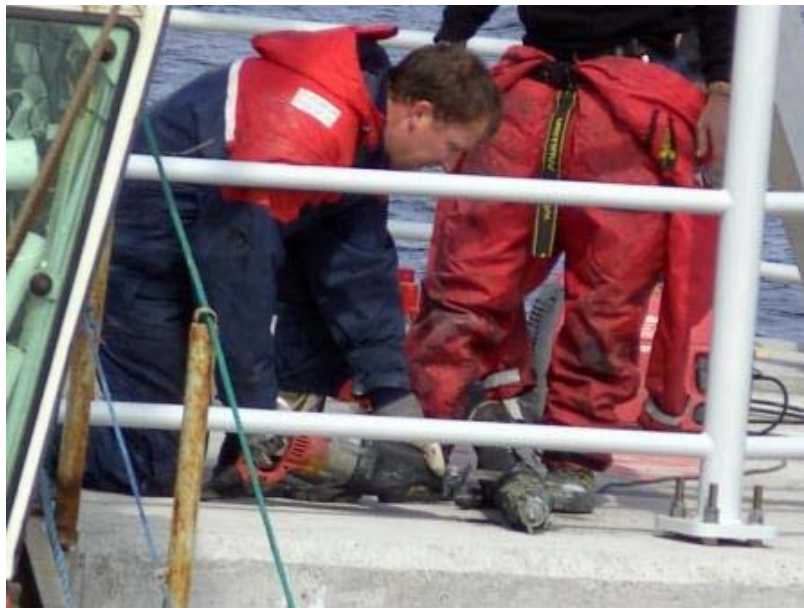
At every foundation where the cable laying was ending there was more cable than necessary. This extra length of cable was cut off using a tiger saw, figure 27.

Figure 27. A tiger saw was used to cut the excess length of cable
